DOE/NASA/20320-30
NASA TM-81719

Test Evaluation of a Laminated Wood Wind Turbine Blade Concept

James R. Faddoul
National Aeronautics and Space Administration
Lewis Research Center

May 1981

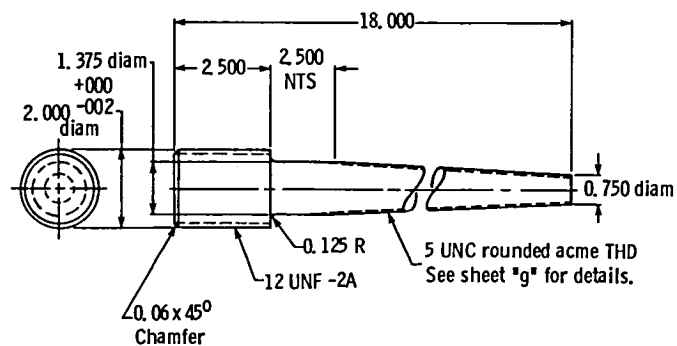
(a) 1 3/8" to 3/4" taper ratio.

Figure 15. - Tapered stud configurations.

1. Stud configuration (imbedded portion) should be tapered similar to that shown in Figure 15(a). Thread type and taper ratio appear to be rather insignificant to overall performance.
2. The hole in the wood should be step tapered.

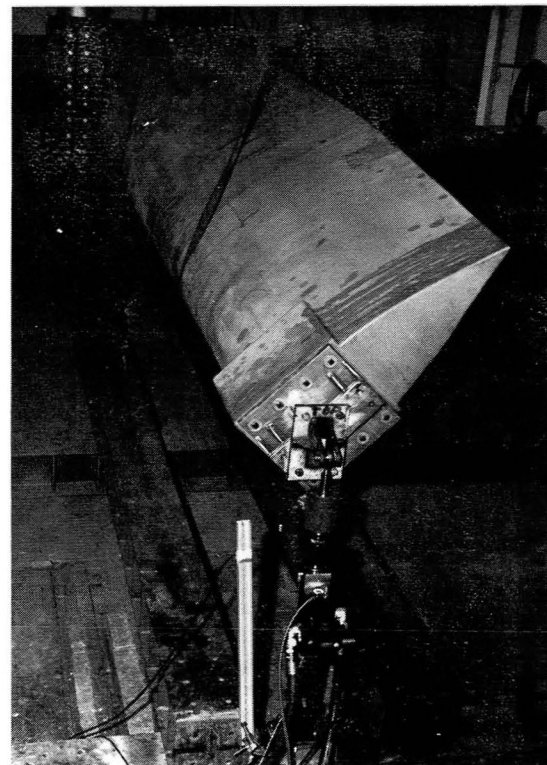
blade was mounted as a cantilever beam to a 2 in. thick steel plate (54 in.²) which was backed up with 12 in. "H" beams having reinforced webs. Figures 27 and 28 show the blade as mounted. The free end of the blade was attached to a hydraulic actuator through a load cell and an LVDT. Load was calibrated as a function of actuator stroke and the test was then controlled by the stroke measurement. Periodic checks were made to determine if changes in load/stroke relationships had occurred. To closely approximate the combined flatwise and edgewise design loads, which reach similar peak values at approximately the same time, the blade chord line was set at a 45° angle to the applied load. The innermost 3 ft of the test section then was subjected to loadings which closely approximated those expected in the field. This had little influence on the outboard portion of the test specimen since the applied moment was well below the peak seen by that part of the blade during actual service. Figure 29 shows a plot of the moment on the blade as induced by wind turbine operations and a comparison of the test moment. Eighteen strain gauges were active for this phase of the testing. Using the data obtained in the Phase I testing, strain/moment values were predicted and found to correlate for most of the active gauges during the initial load deflection tests in the Ft. Eustis facility.

Figure 27. - Twenty foot blade section mounted and ready for test in USARTL (Ft. Eustis) Facility.

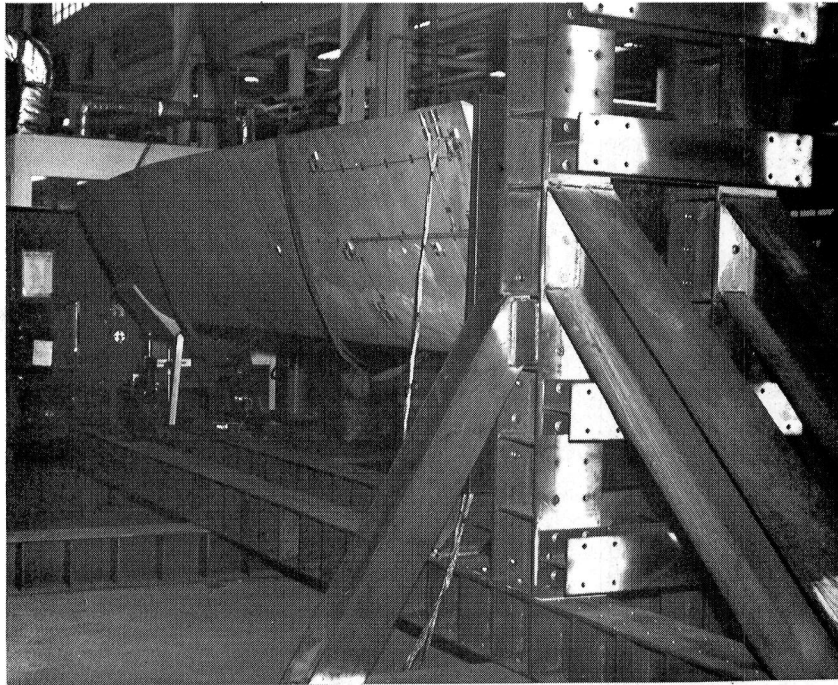
Figure 28. - Mounting and strongback for 20 foot blade test at USARTL (Ft. Eustis) Facility.

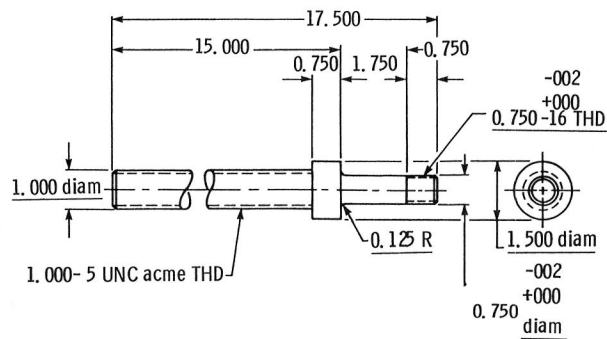
Rather than abandon the test, the specimen was sent back to the contractor, Gougeon Bros., Inc., for replacement of the studs. This became an ordeal as it was quickly learned that removal was not easy. A number of staples had been used in the construction of this blade section (a practice which is no longer used) and the staples made the use of a deep hole saw difficult. An attempt was then made to simply unscrew the studs from the epoxy. This resulted in breaking the stud. The unscrewing technique was then tried in combination with application of a high amperage current to heat the stud and soften the epoxy. This was equally unsuccessful. Finally, the hole saw technique was made to work by "brute force" with the result that a rather large and uneven hole was left in the blade as each stud was removed. These holes were subsequently smoothed and tapered by a large boring cutter and were then filled by matching tapered wood plugs made from laminated fir. When all studs had been removed and the holes filled, the root of the test section was redrilled and fitted with 24 new studs having a slightly modified configuration (Fig. 31) featuring a 3/4 in. diameter threaded shank rather than the

Figure 31. - Drawing of replacement stud in 20' wood blade test section.

previously used 5/8 in. diameter. This modification was based on the decision that mating with a hub spindle on the wind turbine would require a very stiff flange which could quite easily accommodate a 3/4 in. stud. Consequently, prior to sending the test section back to Ft. Eustis, a 10 in. long spool piece was machined (Fig. 32).

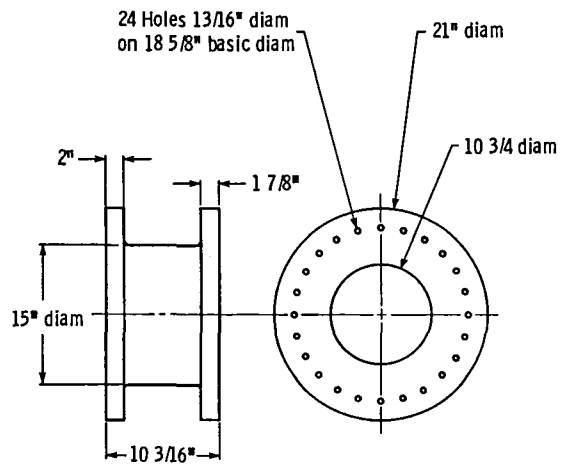
Figure 32 - Spool piece adapter for Fort Eustis testing.

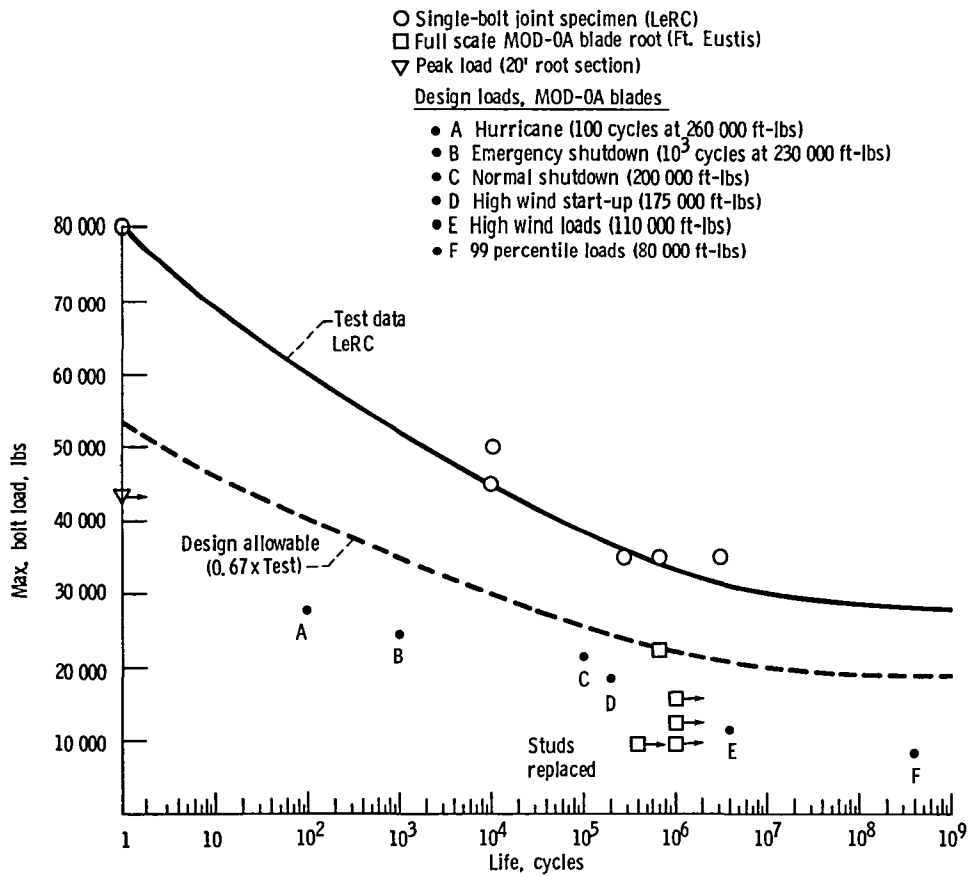
Figure 33 is a summary of the test conditions at Ft. Eustis as compared to both the blade operating requirements and the individual stud test data. It should be noted that Figure 33 has converted the actual test moments to a maximum bolt load based on the number of studs and the bolt circle diameter. To convert back to moment, multiply the bolt load by 9 (approximate) to obtain the moment in ft-lb. The most significant point to be extracted from Figure 33 is, however, that while the actual testing of the blade section was far in excess of the MOD-OA design points there was no failure of the wind or bend joints. In addition, 670,000 cycles were required to fail studs even though there was a severe stress concentration built into the stud and 3×10^6 cycles at lower loads had been previously applied.

Figure 33. - Fatigue data for bolt-to-wood tension joints fabricated by Gougeon Bros., Inc.

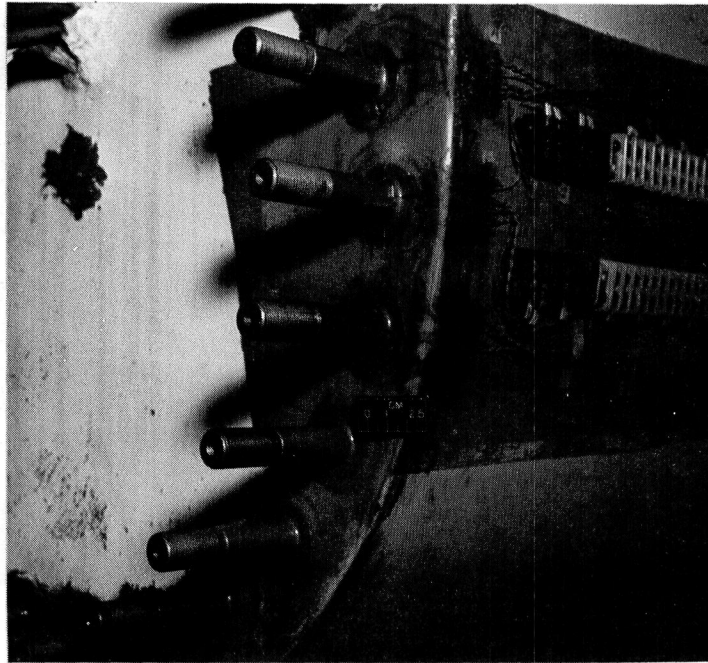
4.3.1. Stud Pretorque Tests. - For this test, three adjacent studs were each instrumented with four strain gauges. The gauges were applied by grinding flats on the unthreaded portion of the 3/4 in. stud. Orientation of the gauges and the studs was as shown in Figure 34. Very fine lead wires (36 gauge) were used and grooves were ground in the face of the stud shoulder to preclude crushing of the wire when the spool was put on and the nuts were torqued. The spool piece was then slipped into position and all the studs but the three having strain gauges (and those broken) were torqued to 150 ft-lb. The blade was then mounted on the test stand as a cantilever beam and the strain gauges on the instrumented studs were zeroed.

Figure 34. - Studs with flats for strain gages (lead wires and strain gages removed).

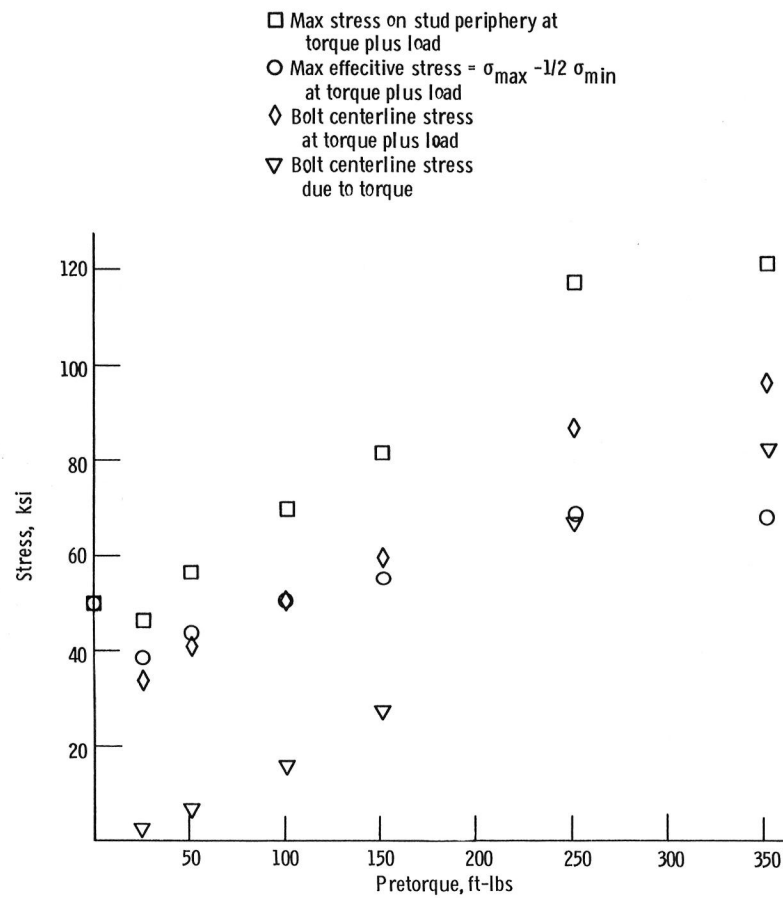
Nuts were then placed on each of the three instrumented studs and pretorque was applied. Then, a bending moment was imposed on the blade in discreet steps and the change in stud strain for each step (including the pretorque step) was measured. The strain data from the four gauges on each stud was then used to determine the center-line stress and a maximum perifial stress for each load level and each stud. Plots of the most highly stressed stud are shown in Figure 35. As can be seen, pretorque of the stud-through-flange configuration of the wood blade does not eliminate the cyclic stresses in the shank of the bolt. This finding is in contrast to the typical flange-to-flange joint where the bolts can be pretorqued to produce a stress that will hold the flange faces together under the highest load to be expected. Normally in a bolted joint with sufficient pretorque in the bolts, subsequent changes in stress in the bolt are very small or non-existent as long as the load does not exceed that for which the pretorque was established. For 3/4 in. bolts, the pretorque can be as high as 400 ft-lb. However, for the stud-to-flange connection of the wood wind turbine blade, pretorque above 250 ft-lb would probably tend to decrease cyclic capability. Additional test data will be developed and reported at a later date. However, it appears that there is a rather broad range of torque values (50 - 200 ft-lb) that will produce satisfactory fatigue results. And, even at 350 ft-lb, the value selected for the fatigue testing at Ft. Eustis, a properly designed stud provides a positive margin of safety on fatigue.

Figure 35. - Effect of pretorque on bolt stresses. (Max loaded tensile stud.)

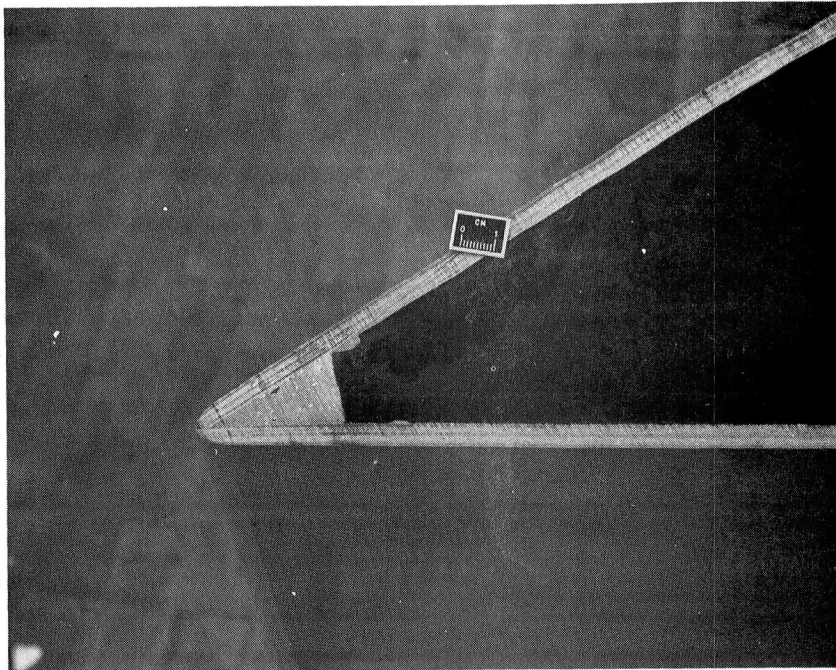
4.3.3. Visual Examination. - After all testing was complete the blade was sectioned for examination. Pertinent photographs are shown in Figures 36 through 43. Only one area of wood cracking was found and can be seen quite clearly in Figure 39. It is not known what caused this crack but it could have come from the work of replacing the studs or from the sectioning operation itself. Due to its location, it is not considered to be a result of the fatigue or ultimate loads.

Figure 36. - Trailing edge bond of sectioned 20 foot blade test specimen.

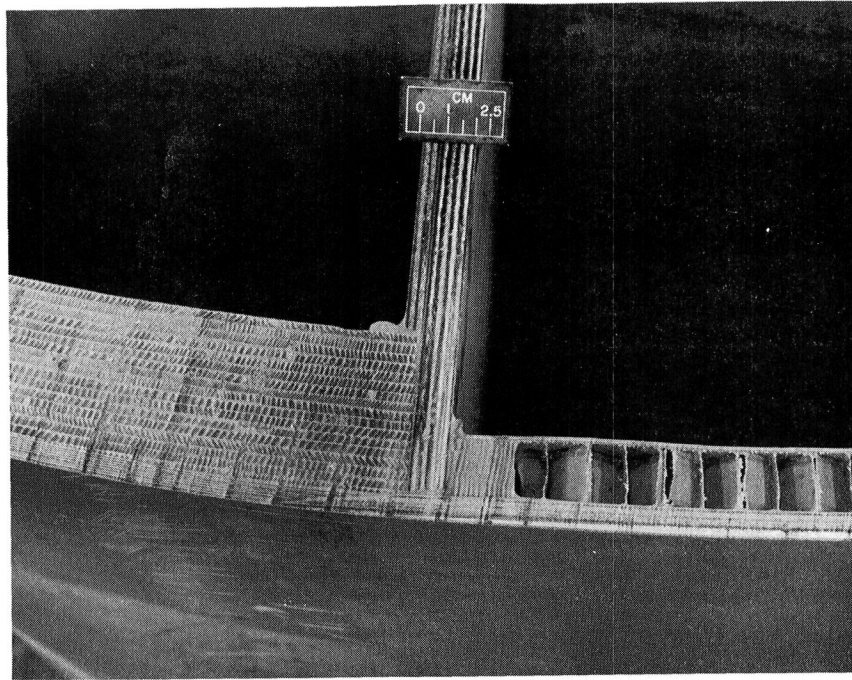
Figure 38. - "D" Spar/Shear web/trailing edge connection of 20 foot wood specimen.

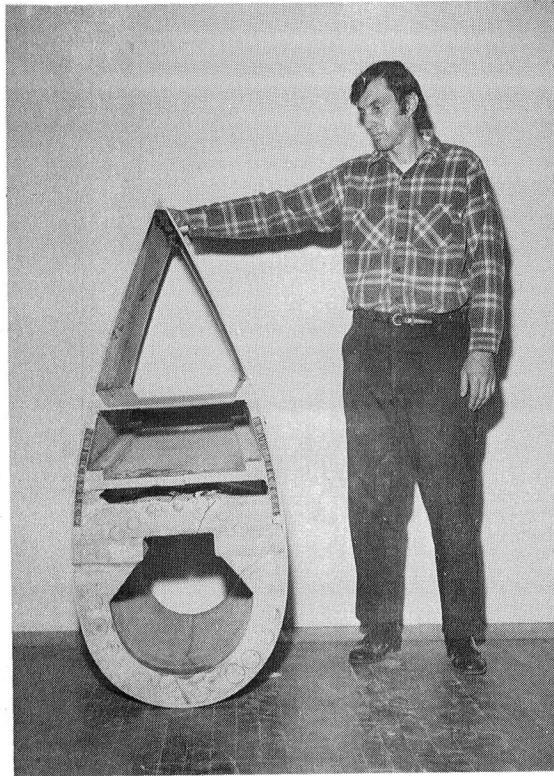
Figure 40. - Inboard section cut from 20 foot wood blade test specimen.

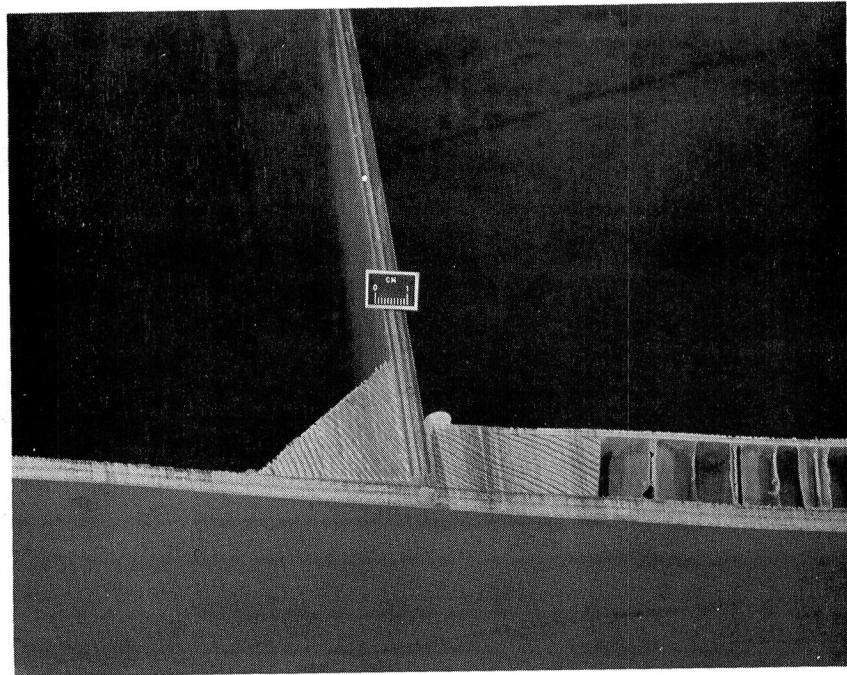
Figure 42. - Shear web and Vertical reinforced afterbody panel in outboard portion of 20 foot test section.
